Technical reports

Acoustic emission, an innovative diagnosis tool for therapeutic hyperbaric chambers: or how to requalify safely using pneumatic pressure test

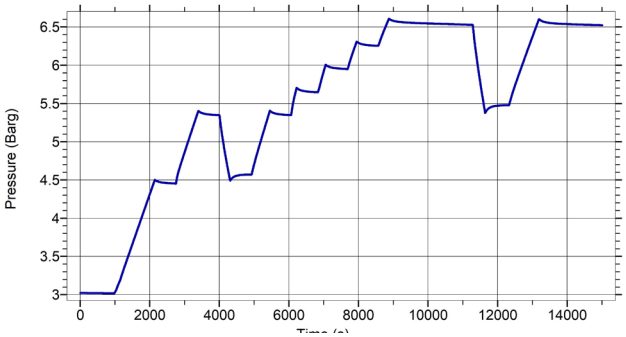
Figure 4
Actual pressurisation cycle (Scylla airlock); Barg – pressure in Bar (gauge)

Compliance with the pressurisation cycle defined in the test procedure is essential. Also, the engineers in charge of the hyperbaric chambers at the Lille University Hospital configured the means of pressurisation to allow, on the one hand, the recommended cycle to be respected (Figure 4), but on the other hand, to make pressurisation of the vessel as quiet as possible (so as not to disturb the sensors).

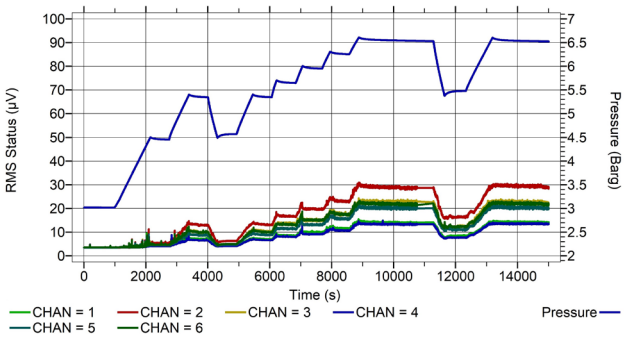
In the case of the pressure test of the Scylla airlock, this analysis made it possible to highlight a minor leak which was not detectable from a pressure measurement but nevertheless present. Figure 5 shows the root mean square voltage values for each sensor. The most affected sensor in this case being sensor c2 (channel 2), which revealed a minor leak in the area of the door between Poseidon and Scylla.

During the acoustic emission test, we detected small anomalies such as the detection of a leak in the area of the door between Poseidon and Scylla. The high sensitivity of the acoustic emission technique to turbulent flow enabled the detection of a small leak that would otherwise be imperceptible. Thanks to a dense network of sensors, it was possible to localise this leak. Moreover, as the data are continuously recorded during the test, acoustic emission can characterise the level of pressure from which the leak has been detected. A simple pressure test without acoustic emission monitoring would have not highlighted such leak, as the pressure loss is not easily measurable, and would not have been able to give any information on its localisation.

Analysis of the Scylla airlock test showing root mean square (RMS) voltage values recorded for channels c1 to c6; CHAN – sensor channel

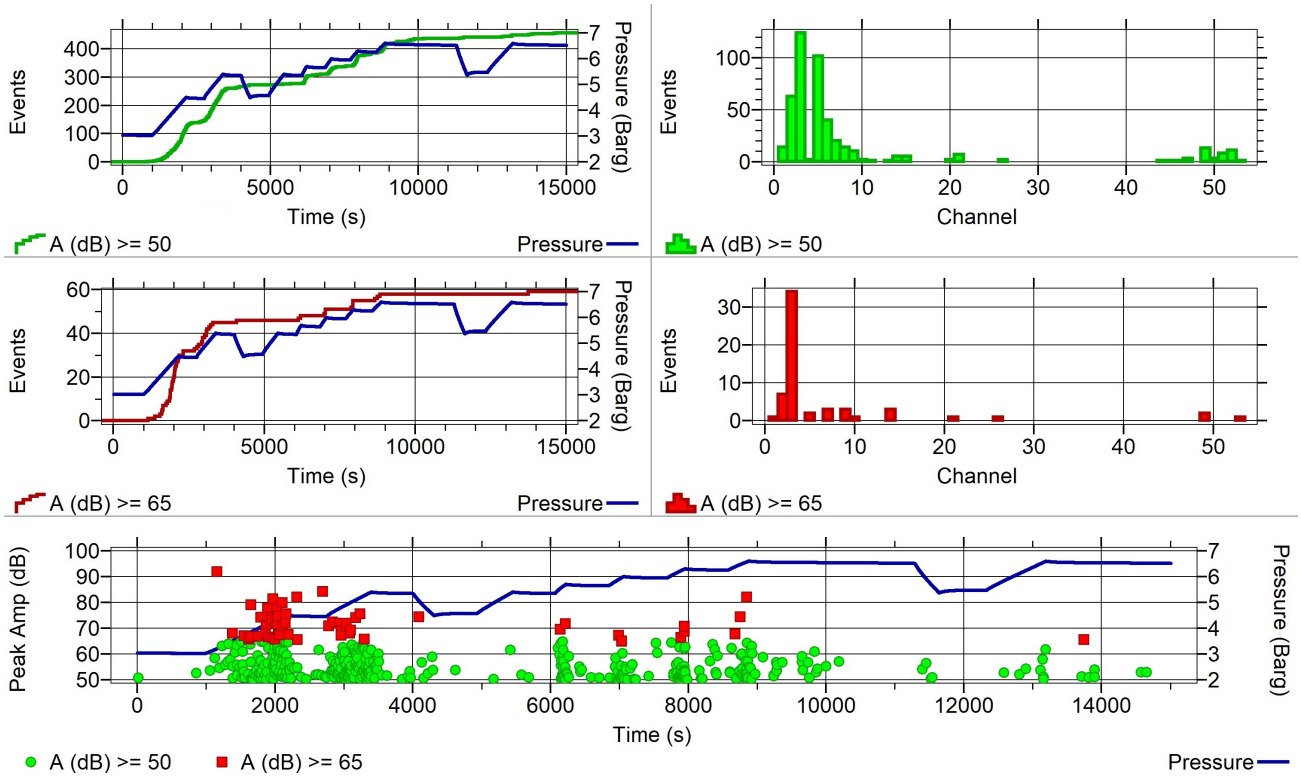
Figure 6 illustrates a summary of the zonal analysis of Scylla. In particular, we were able to observe that the area covered by sensor c3 was the most emissive (events vs channel graphs, at the right).

Zonal location analysis of the Scylla airlock test; Barg – pressure in Bar (gauge)

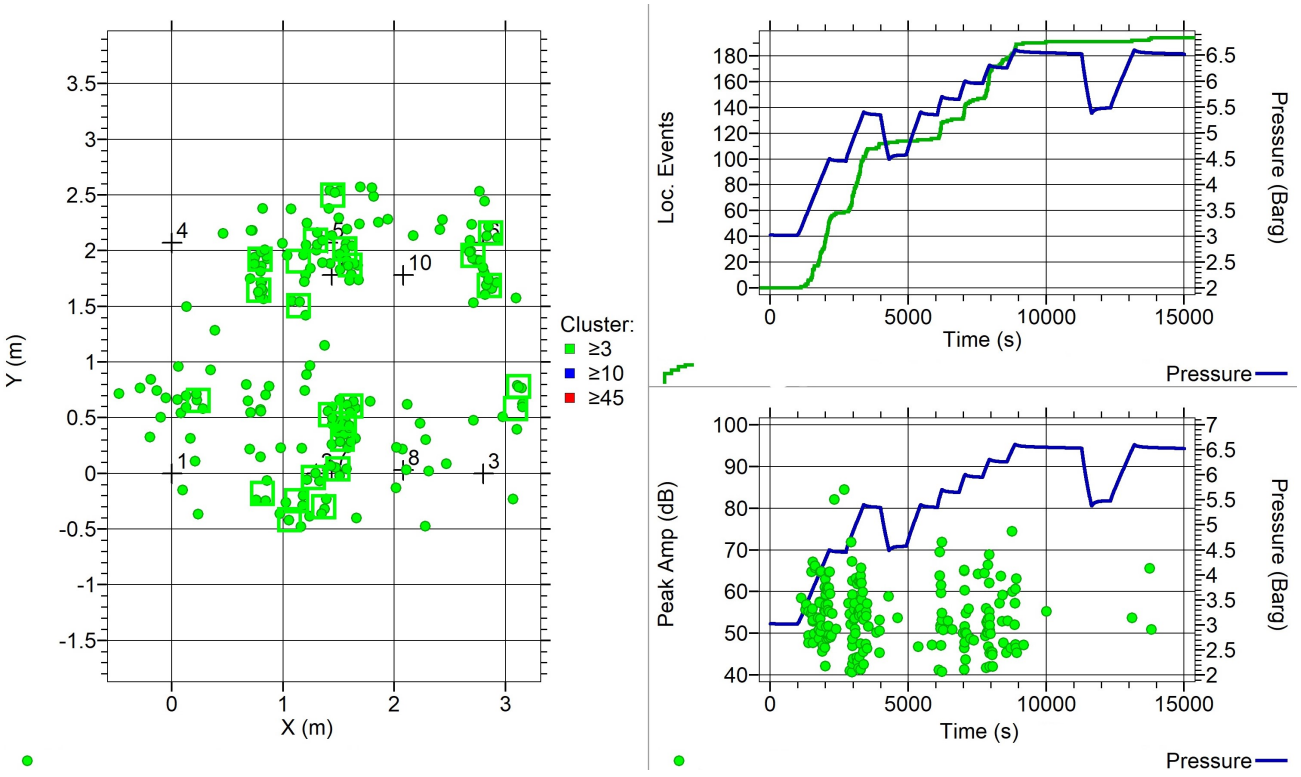
Figure 7 illustrates the acoustic activity map for part of the Scylla airlock.

Planar location analysis of the Scylla airlock test; Barg – pressure in Bar (gauge) X & Y – coordinates of the located events
